## The Case of Lightning Protection Solutions for Electric Power Facilities

# Case Studies

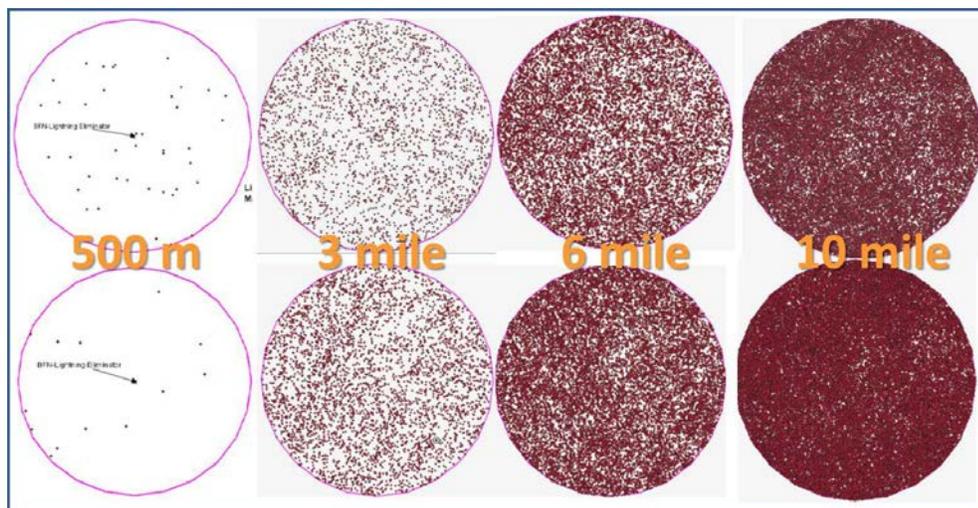
- **1996 – 1998:** Cloud to Ground Lightning Strike Count (Top)  
500 meters: 40 | 3 miles: 2,630 | 6 miles: 11,277 | 10 miles: 33,685
- **1999 - 2001:** Cloud to Ground Lightning Strike Count (Bottom)  
500 meters: 13 | 3 miles: 4,327 | 6 miles: 18,688 | 10 miles: 55,199

80% reduced within 500m when normalized to strikes in 10 mile circle
